BA-3077
Clagett- Schmidt House and Store
9101-9105 Liberty Road
Randallstown
Private
c. 1900, c. 1926-35.

Maryland Inventory of Historic Properties Form

Inventory No. BA-3077

Name Claggett-Schmidt House and Store
Continuation Sheet

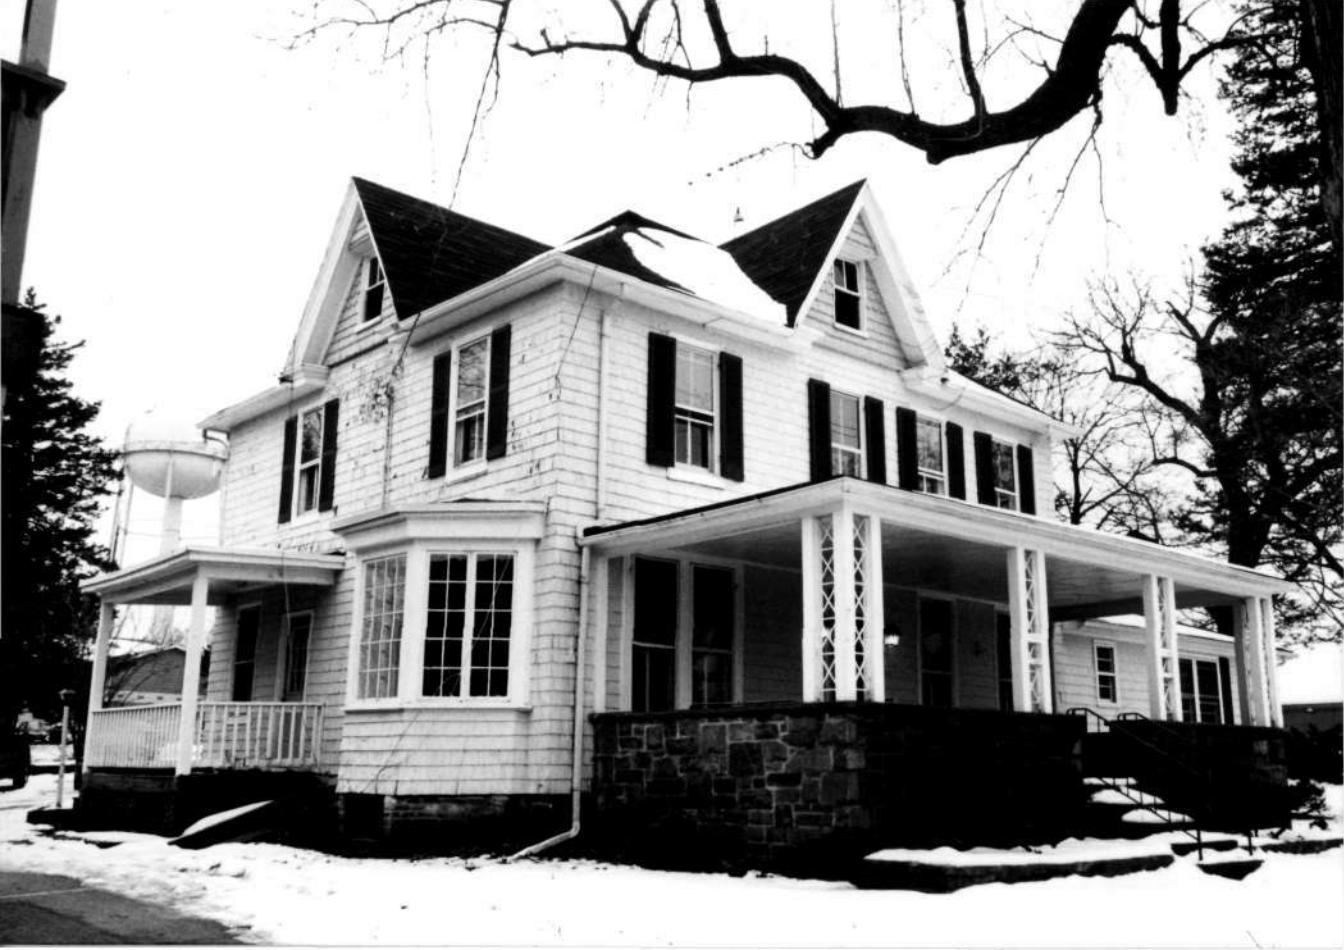
1/4

SE & NE elevs

The house at 9105 Liberty Road faces northeast toward the Road, near the corner of Offut Road. It is a 2 ½-story, four-bay by two-bay frame structure with wood shingle siding, a rubble stone foundation, and a hip roof with asphalt shingles. The center of the main block roof is flat. There is an ell attached to the southwest elevation that is one bay by two bays and two stories tall. The ell has a hip roof. On the northeast elevation the first story has paired two-over-two sash with wood sills in the east bay, a six-panel door with a two-light transom in the east-center bay, and a single typical two-over-two sash in the north-center and north bays. There is a four-bay, one-story porch with partly coursed and dressed rubble stone walls, paired square posts, and a hip roof. The second story has four two-over-two sash. There is a wood box cornice and a central gabled wall dormer with saw tooth pattern wood shingles at the top and bottom, fish scale shingles in the center, and square butt shingles between. The dormer has a typical two-over-two sash, and above it the wall with the shingles projects to the front of the deep-set eaves.

On the southeast elevation the first story south bay has a typical two-over-two sash and a new door. There is a one-bay porch set on brick piers that support square wood posts and balusters, and it is covered by a hip roof. The east bay has a three-sided bay window with twenty lights on the southeast side and paired ten-light casements on the south and east sides. The bay window has a brick foundation. The second story has two typical two-over-two sash, and there is a gabled wall dormer that is identical to that on the northeast elevation.

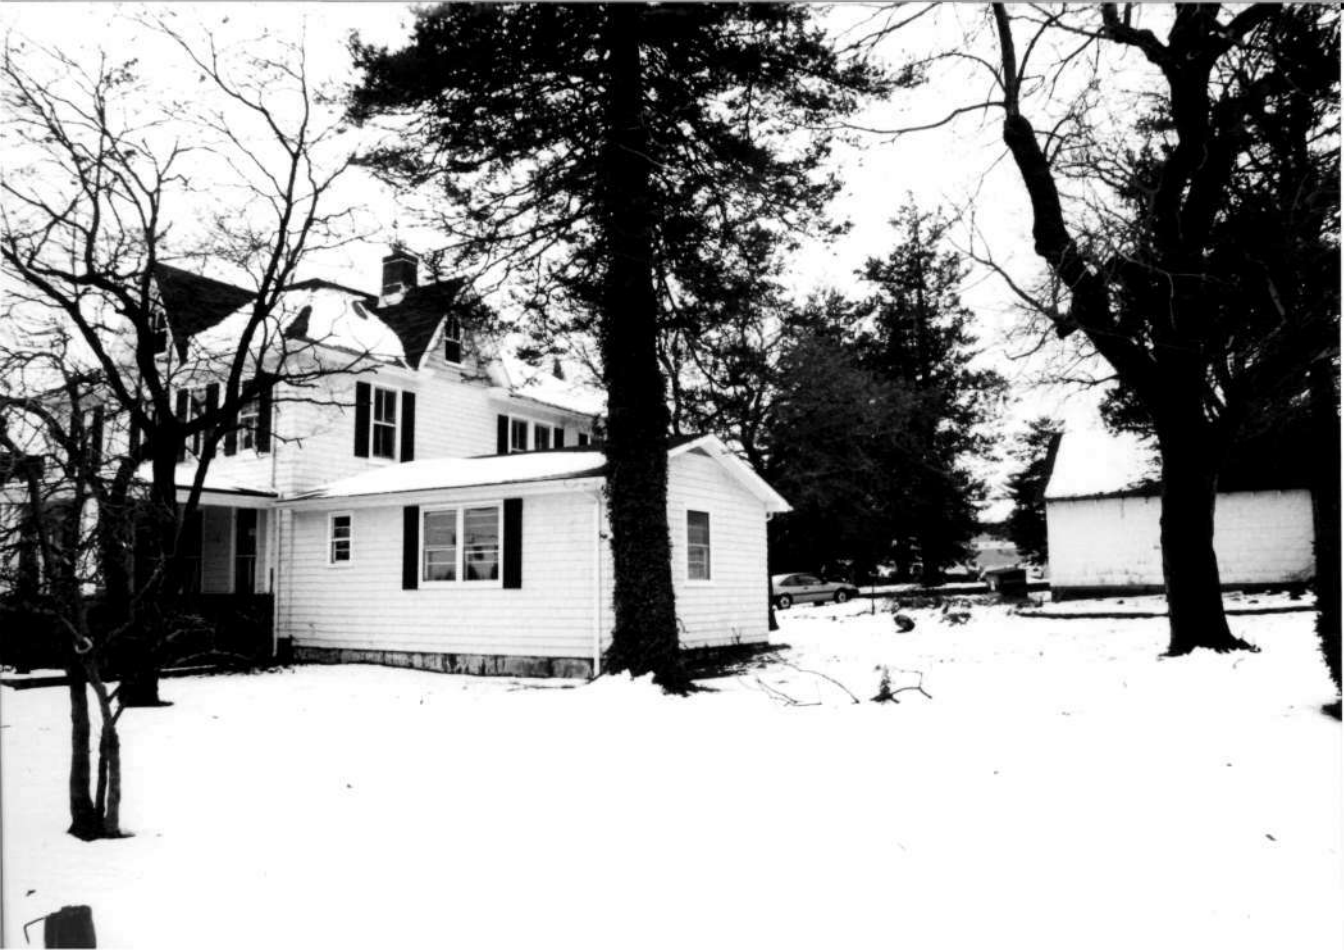
2/4

NE & NW elevs, w/ garage

The northwest elevation is three bays, with one bay being the rear ell. There is a large modern addition on the first story of the main block, and it has a concrete foundation, wood shingles, and a low pitch gable roof with asphalt shingles and a northwest-southeast ridge. To the west of the addition is a modern bay window, and there is a typical two-over-two sash in the ell. The second story has a two-over-two sash in the north bay and paired two-over-two sash in the west bay of the main block. The ell has a two-over-two sash. There is a dormer identical to that on the northeast, and an interior brick chimney centered on the ridge of this dormer.

West of the house, at the back of the lot, is a garage with a concrete foundation, asbestos shingle siding on the southeast and northeast elevations, and wood shingle siding on the northwest. It has a gable roof with asphalt shingles, a northwest-southeast ridge, and exposed rafter ends. The southeast elevation has a large, double-width roll-up door. There is a boarded-up window on the northeast elevation.

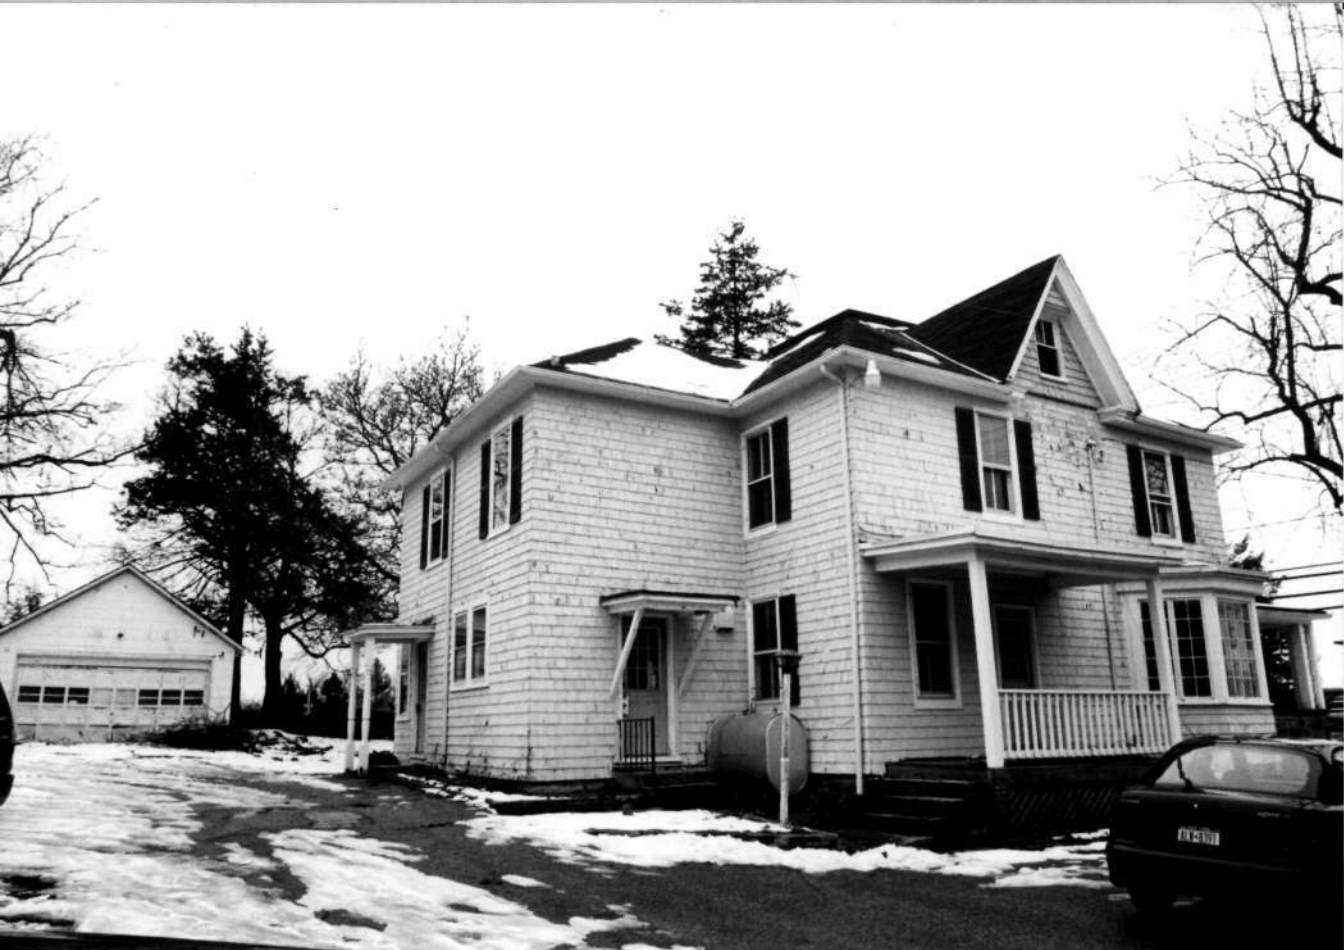
3/4

SW 25 C & Lous, w/ garage

The southwest elevation of the ell is two bays. The first story has a narrow two-over-two sash and a new door in the west bay, with a small porch here that has turned posts and a low hip roof. The south bay has short, paired two-over-two sash. The second story has two typical two-over-two sash. The southeast elevation of the ell is one bay, with a new door on the first story covered by a low hip roof supported by angled posts. The second story has no openings. The southwest elevation of the main block is one bay, with a typical two-over-two sash on both the first and second stories.

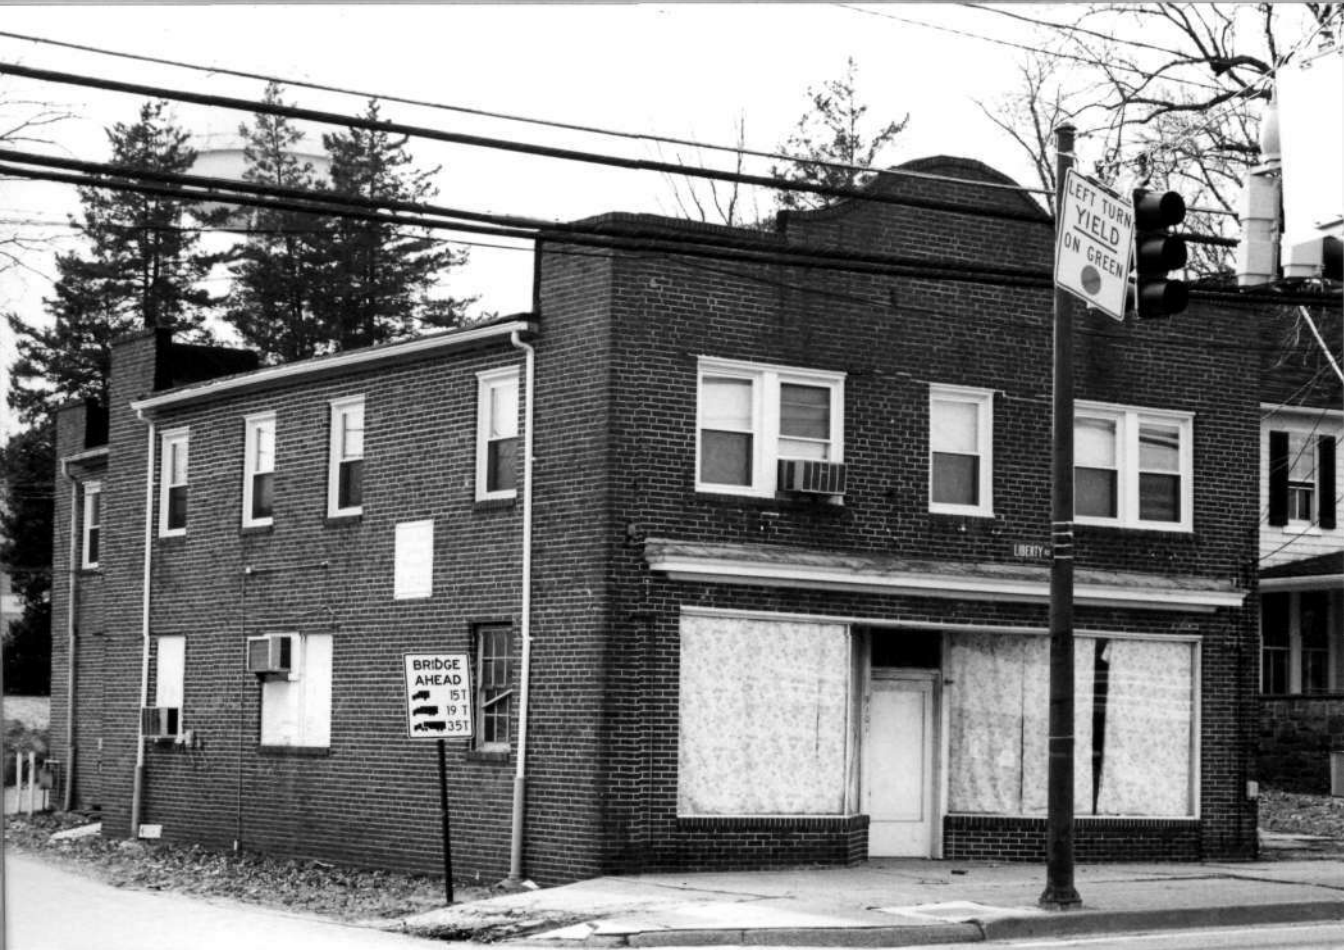
4/4

Store-SE & NL class

At the east corner of the lot, at 9101 Liberty Road, is a two-story brick commercial building with a storefront on the northeast elevation of the first story. It is a three-bay by four-bay structure with a flat roof and five courses of headers to one course of Flemish bond. There is a two-story wing on the rear that is two bays deep and three bays wide, but is narrower than the main block on both sides.

The northeast elevation has a recessed door in the center with one light and a three-light transom. There is one large plate glass show window on each side. The second story has a new one-over-one sash in the center and paired one-over-one sash to each side. There is a parapet with a reverse curve pediment. On the southeast elevation the first story has a boarded-up window to the south and a boarded-up pair in the center, and a six-over-six sash to the east. The second story has four new one-over-one sash. The southeast elevation of the wing has a boarded-up window to the south and a flush door to the east on the first story. The door was a shed-roof porch with one square wood post. The second story has two one-over-one sash.
